The REMR Bulletin

VOL 4, NO. 1

Precast Concrete Stay-In-Place Forming System for Lock Wall Rehabilitation

Remedial Measures to Control Excessive Leakage at Richard B. Russell Dam

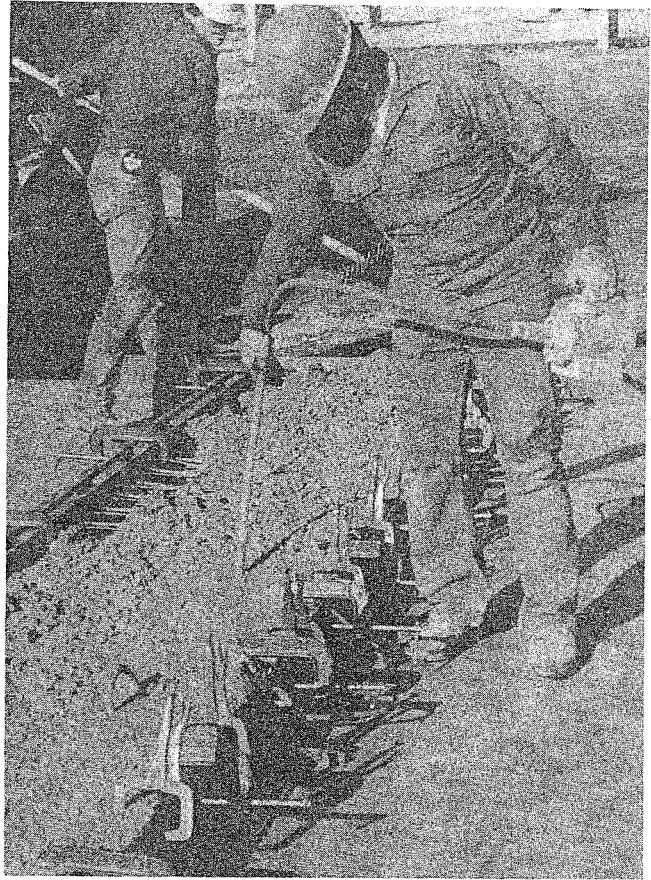
Figure 4. Panel precasting

After being placed, the concrete was consolidated with internal vibrators (Figure 4). The concrete was then screeded to the required thickness and finished with magnesium floats. During the floating operation, the C-clamps, which were used to secure embedments, were removed and the resulting depressions filled. As a final step,

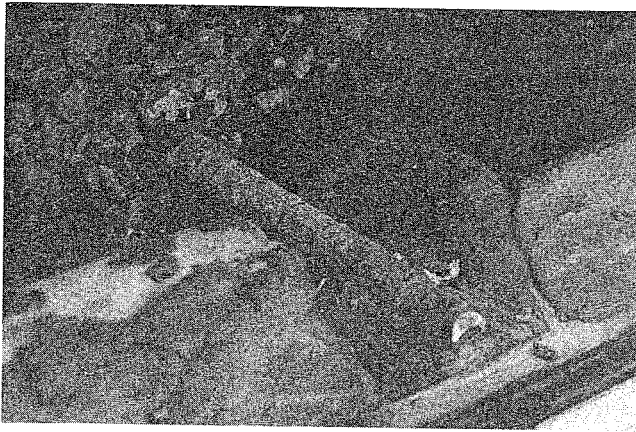
Figure 7. Shear key at top of panel P-1 prepared for installation of panel P-2

Prior to erecting the next panel (P-2), a neoprene seal was bonded to the top bearing surface of panel P-1, shims were installed, and a nonshrink grout was buttered onto the sloping face of the shear key (Figure 7). In addition, the back face of the shear key had to be bushhammered and ground to obtain a proper contact surface for the alignment angle on the succeeding panel. This additional work resulted from an oversight during precasting. Extending the rake finish on the back of the panel to the top of the shear key resulted in an uneven bearing surface which would have prevented a flush alignment between adjacent panels.
